**Flood Control Project Maintenance
Levee Inspections
LMA District Cover Sheet
Spring 2010 Levee Inspection Results**

Sutter Maintenance Yard Maintenance Area 0007

Waterway				Bank	Unit Miles
Unit No. 01 Feather River				Right	12.07
	Spring (March - May)	Summer (June - August)	(September - November) Fall	Winter (December - February)	
Unit Maintenance Rating (Fall Only)					
Date of Inspection	4/14/2010 - 4/14/2010				
DWR Inspector	Clay Thomas				
Accompanied By	Jason Cooper

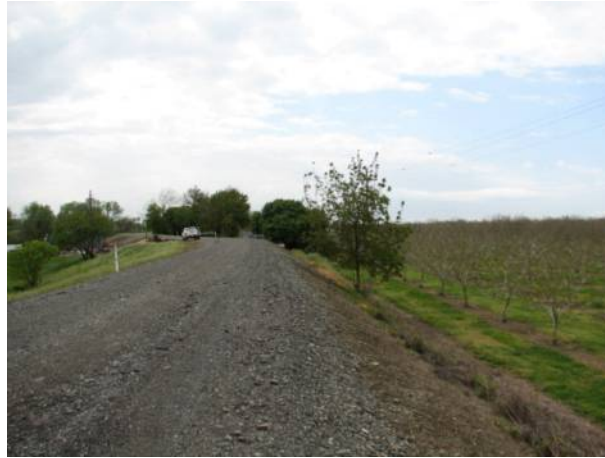
Levee Mile Report Line	1
Start Levee Mile	0.00
End Levee Mile	11.78
Location	Land Side
Category	Earthen Levee
Item	Vegetation

Land side vegetation levee mile 11.50.

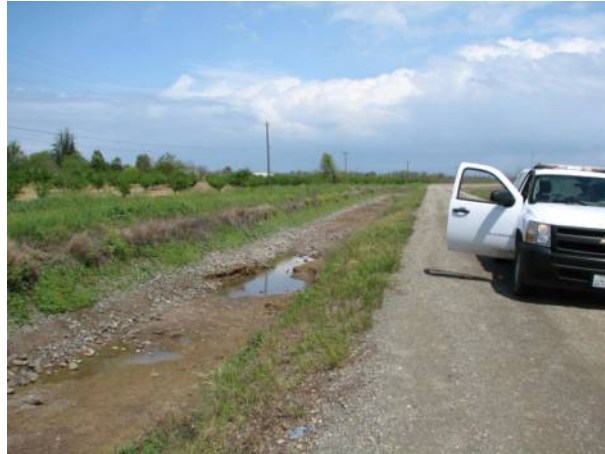
Levee Mile Report Line	1
Start Levee Mile	0.00
End Levee Mile	11.78
Location	Land Side
Category	Earthen Levee
Item	Vegetation

Land side vegetation levee mile 0.00.

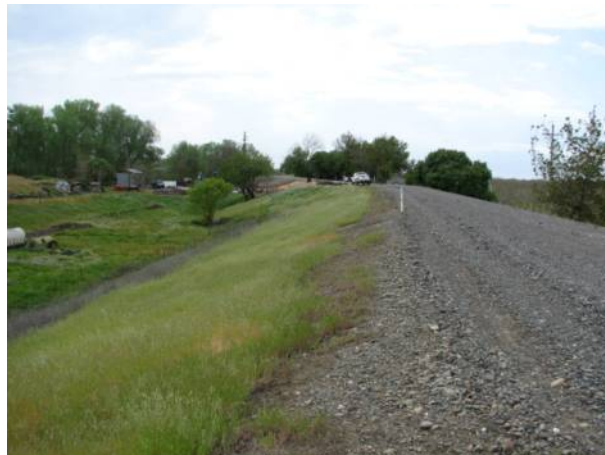
Levee Mile Report Line	2
Start Levee Mile	0.00
End Levee Mile	11.78
Location	Water Side
Category	Earthen Levee
Item	Vegetation

Water side vegetation levee mile 11.50.

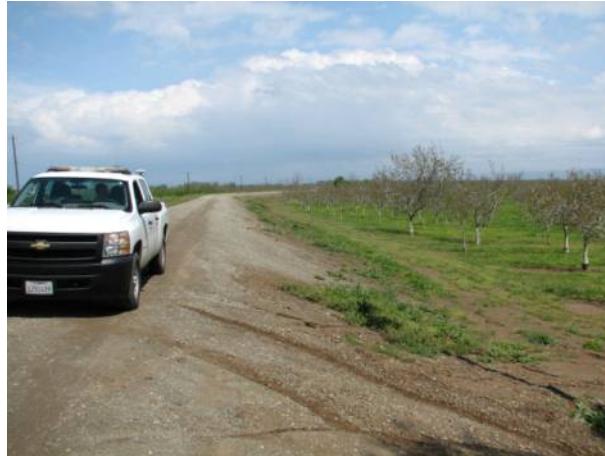
Levee Mile Report Line	2
Start Levee Mile	0.00
End Levee Mile	11.78
Location	Water Side
Category	Earthen Levee
Item	Vegetation

Water side vegetation levee mile 0.00.

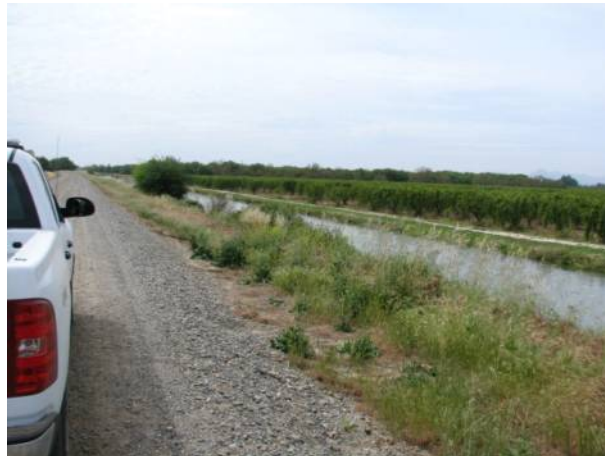
Levee Mile Report Line	3
Start Levee Mile	0.01
End Levee Mile	1.73
Location	Land Side
Category	Earthen Levee
Item	Encroachments

AG ditch land side slope and toe.

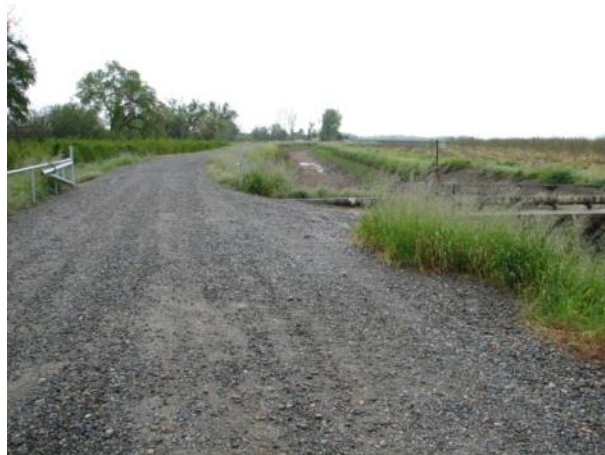
Levee Mile Report Line	3
Start Levee Mile	0.01
End Levee Mile	1.73
Location	Land Side
Category	Earthen Levee
Item	Encroachments

Land side levee mile 1.73.

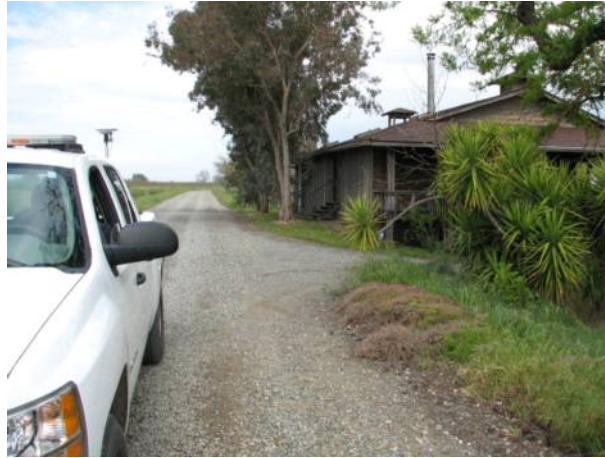
Levee Mile Report Line	4
Start Levee Mile	1.21
End Levee Mile	1.21
Location	Water Side
Category	Earthen Levee
Item	Encroachments

Water side levee mile 1.21.

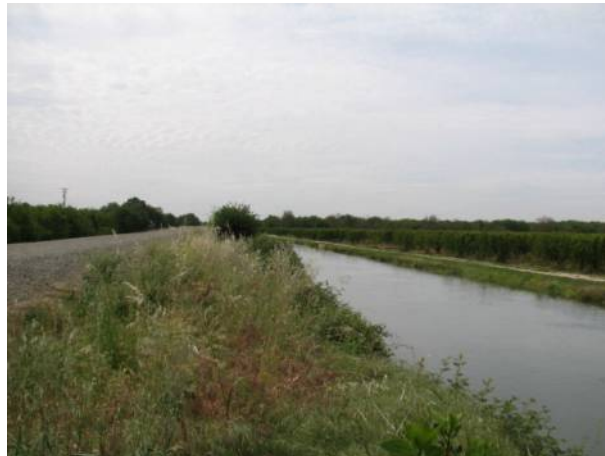
Levee Mile Report Line	6
Start Levee Mile	3.85
End Levee Mile	5.37
Location	Land Side
Category	Earthen Levee
Item	Encroachments

AG ditch land side slope and toe.

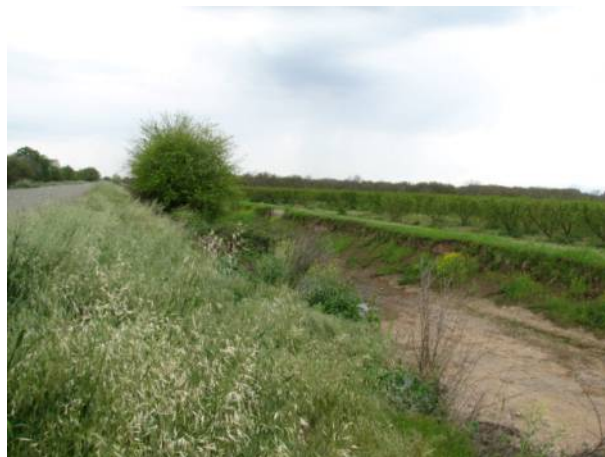
Levee Mile Report Line	6
Start Levee Mile	3.85
End Levee Mile	5.37
Location	Land Side
Category	Earthen Levee
Item	Encroachments

Land side levee mile 5.37.

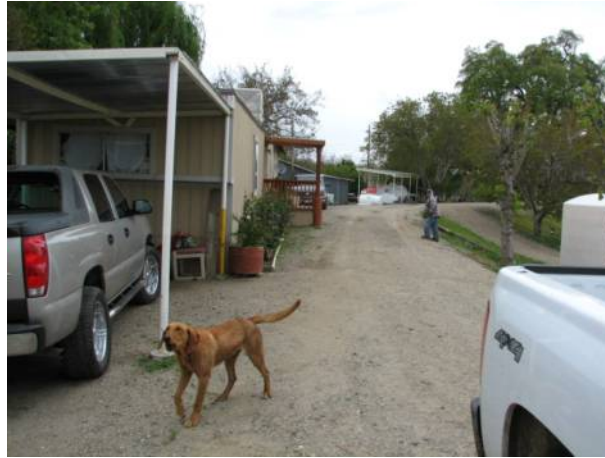
Levee Mile Report Line	7
Start Levee Mile	5.42
End Levee Mile	5.42
Location	Land Side
Category	Earthen Levee
Item	Encroachments

Crown and land side levee mile 5.42.

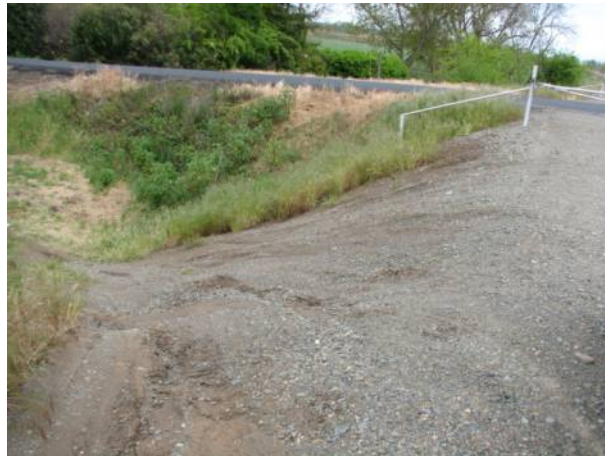
Levee Mile Report Line	9
Start Levee Mile	8.00
End Levee Mile	8.00
Location	Land Side
Category	Earthen Levee
Item	Erosion / Bank Caving

Land side levee mile 8.00.

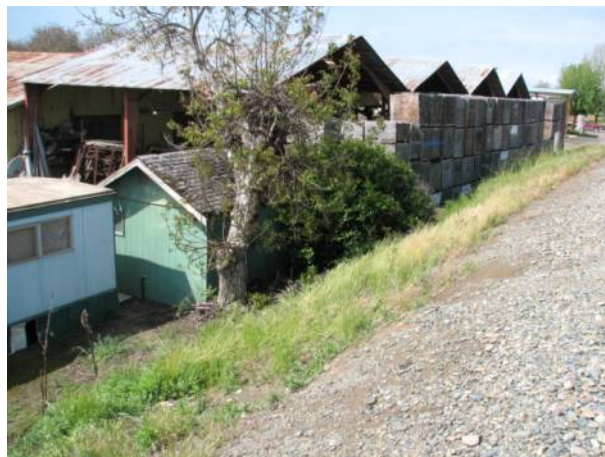
Levee Mile Report Line	11
Start Levee Mile	9.79
End Levee Mile	9.79
Location	Land Side
Category	Earthen Levee
Item	Encroachments

Land side levee mile 9.79.

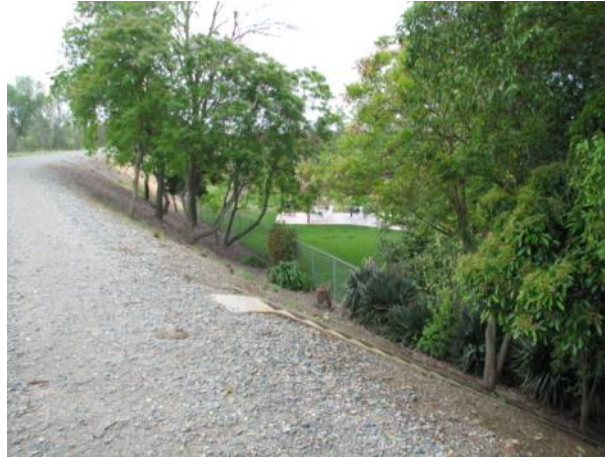
Levee Mile Report Line	13
Start Levee Mile	11.63
End Levee Mile	11.69
Location	Land Side
Category	Earthen Levee
Item	Encroachments

Land side landscaping levee mile 11.63.
